PB91-916301  
NTSB/RAR-91/01

## RAILROAD ACCIDENT REPORT

DERAILMENT OF  
SOUTHEASTERN PENNSYLVANIA  
TRANSPORTATION AUTHORITY (SEPTA)  
COMMUTER TRAIN 61  
PHILADELPHIA, PENNSYLVANIA  
MARCH 7, 1990

ADOPTED: APRIL 23, 1991  
NOTATION: 5281C

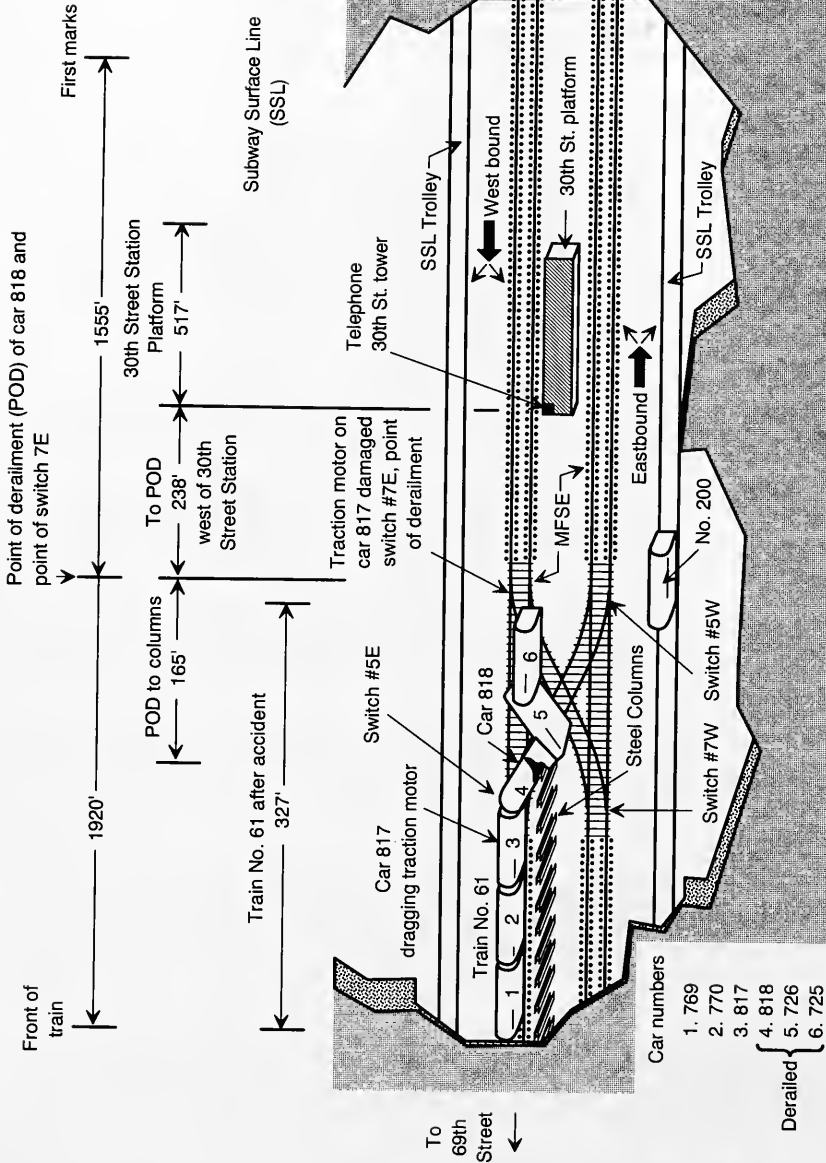
Figure 2.--View of the accident scene at the SEPTA MFSE 30th Street station.

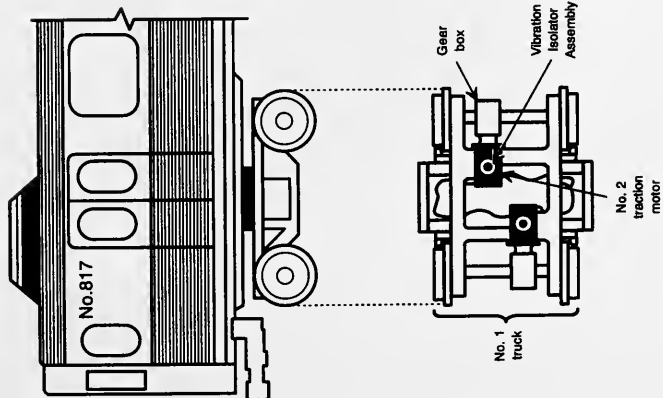
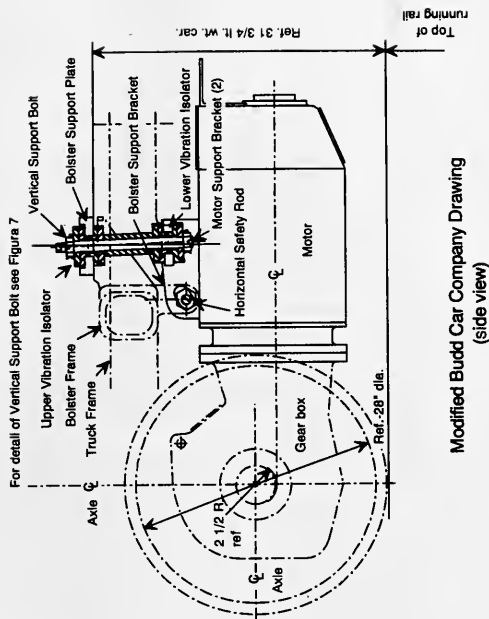
Figure 5.--Truck assembly and traction motor support attachment to truck assembly.

**Safety Rod and Traction Motor Support Brackets.**--The shank of the horizontal safety rod was extensively worn in two spots. On assembly, the two spots corresponded to the positions of the two vertical members of the motor support brackets. (See figure 5.)

The motor support brackets had gaps in both of the vertical members that surround the horizontal safety rod. The texture of the surfaces around the gaps were indicative of heavy side-to-side abrasion with another object, such as the horizontal safety rod. Fracturing was not evident. The distance from the top of the oval-shaped hole in each vertical member of the bracket to its upper surface was approximately 1 1/4 inches. The maximum hole dimension measured approximately 3 5/16 inches. These measurements complied with the engineering drawing cut out dimension requirements for these holes. Hardness measurements of the motor support bracket gave values averaging HRC 1 (RB 83), which was much softer than the specified hardness for the horizontal safety rod.

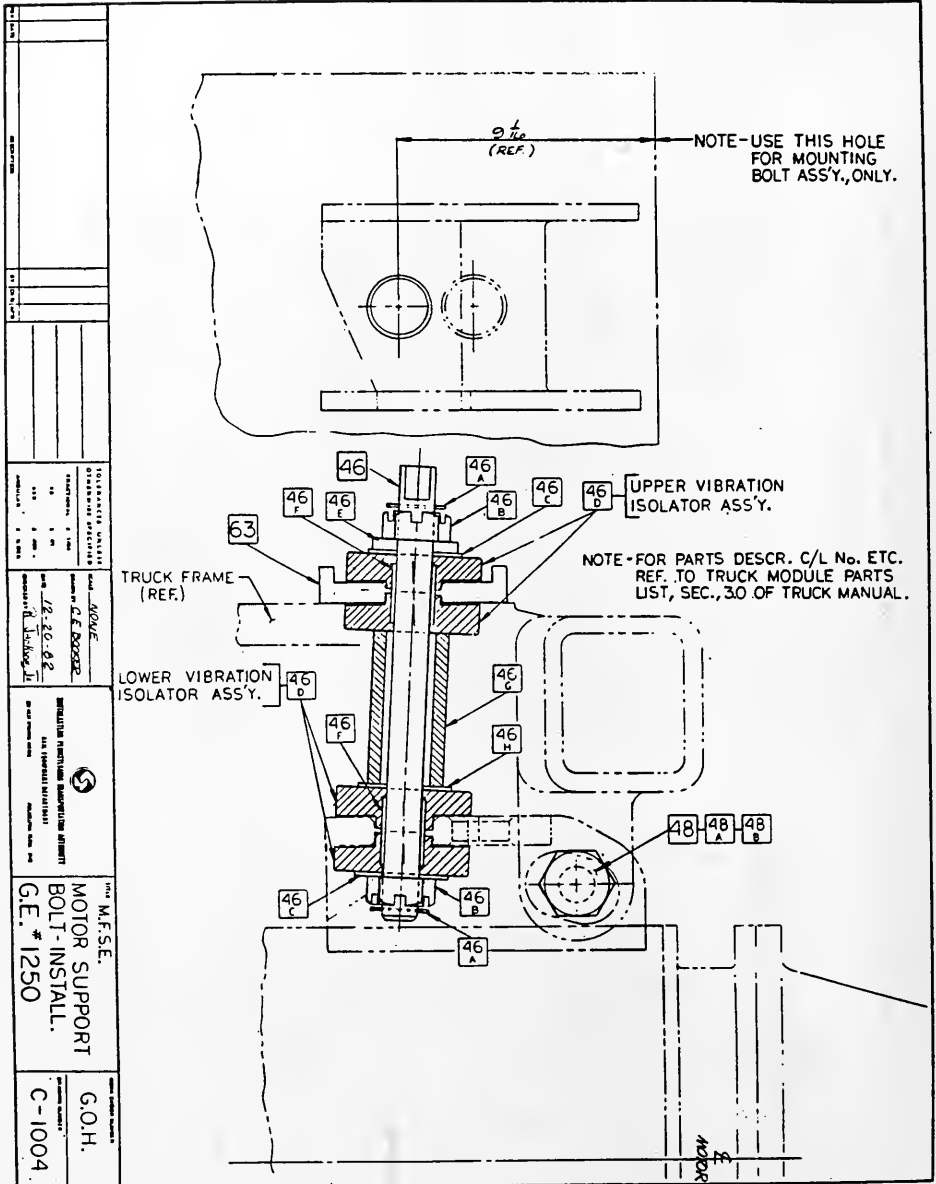
Figure 6.--SEPTA vertical support bolt drawing No. C-1004.

When the Safety Board reviewed SEPTA mechanical drawing No. C-1004 (see figure 6), it found that the upper part of No. 46F was a shorter metal sleeve than was the sleeve in the lower part of No. 46F. However, the drawing showed no washer between the lower half of the upper vibration isolator assembly (46D) and the metal sleeve between the upper and lower isolator assemblies (46G). This is in conflict with the Budd Car Company's original drawing in which a washer was shown at this location. (See figure 7.) Safety Board investigators found that both the upper and lower metal sleeves on the vertical support bolt from car 817 were 2 inches long, and SEPTA officials testified that 2-inch sleeves had been used for both the upper and lower vibration isolator assemblies for as long as they could remember.

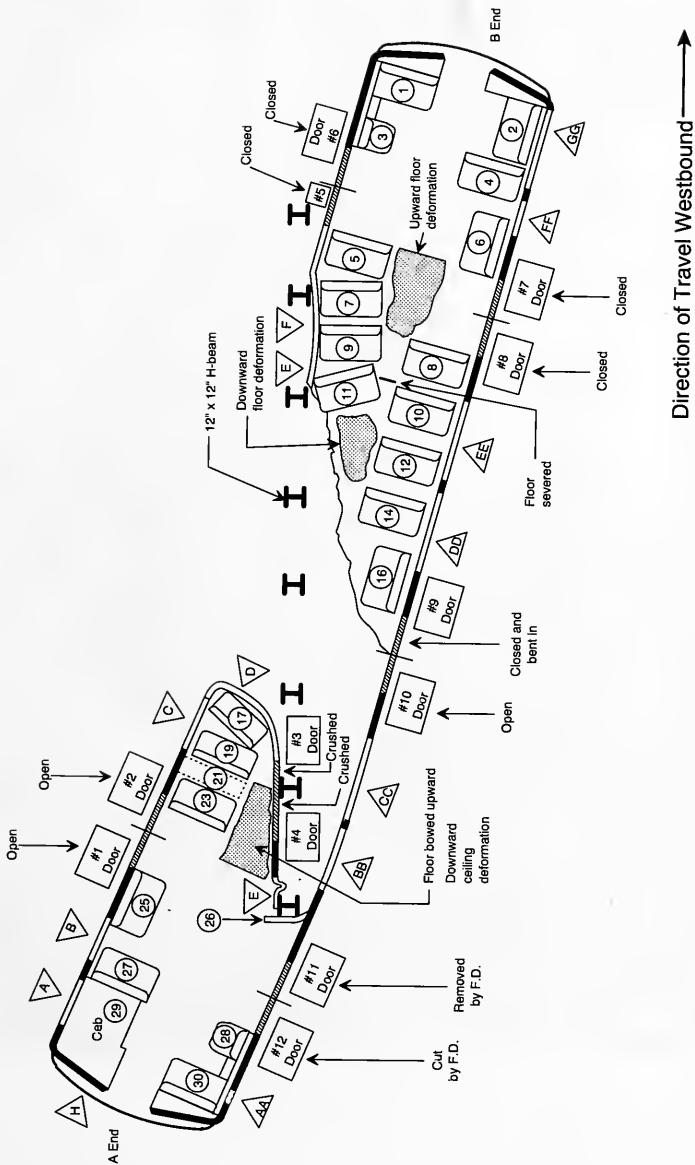
Figure 8.--Damage profile of car 818.

The first three cars (769, 770, and 817) were not derailed. The fourth car (818) derailed in the crossover between the eastbound and the westbound tracks. The lead truck wheels of the sixth car (725) were derailed in the crossover on the westbound track. This car's rear truck wheels were on the closure rails of the turnout. The fifth car (726) was derailed in the crossover. The left side of car 818 (the fourth car) collided with steel 12-inch by 12-inch H beam uprights that were 165 feet west of switch 7E. The car's body was sheared open for 30 feet and was almost severed near the midpoint. (See figures 8 and 9.)

The ceiling panels of car 818 had several cracks between the B end and the first vent fan. The ceiling between the first and second fan had cracks on the right panel. The left panel was missing. Insulation and roof structure were hanging into the

passenger compartment. The ceiling panels between the third and fourth fans were destroyed, and the roof structure was hanging into the passenger compartment. The roof had been pushed down until it was only 55 inches (a little more than 4 1/2 feet) above the floor. The panel between the fourth fan and the A end showed minor cracking. Ninety percent of the interior lights were shattered or missing. The only vertical grab rails that remained secured to the ceiling were between the fourth ceiling fan and the A end.
